System One Cab04 Radio Turn on Fix

May 16, 2011

Mark Schutzer

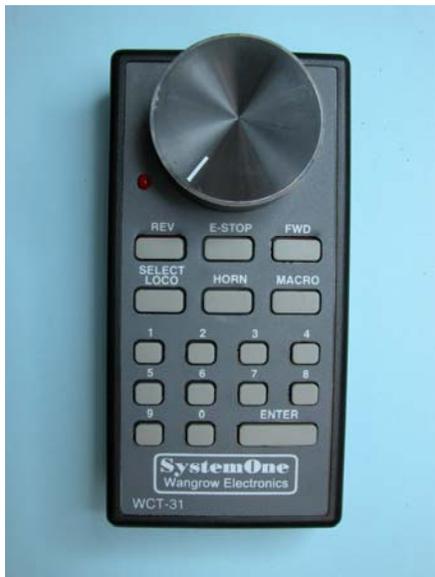
Early System One Cab04's that later had radios installed in them. The part number on the internal circuit board in these cabs is 10006-9001 Rev A. These cabs use a DIP switch to set the cab address. See the photo of the cab below:

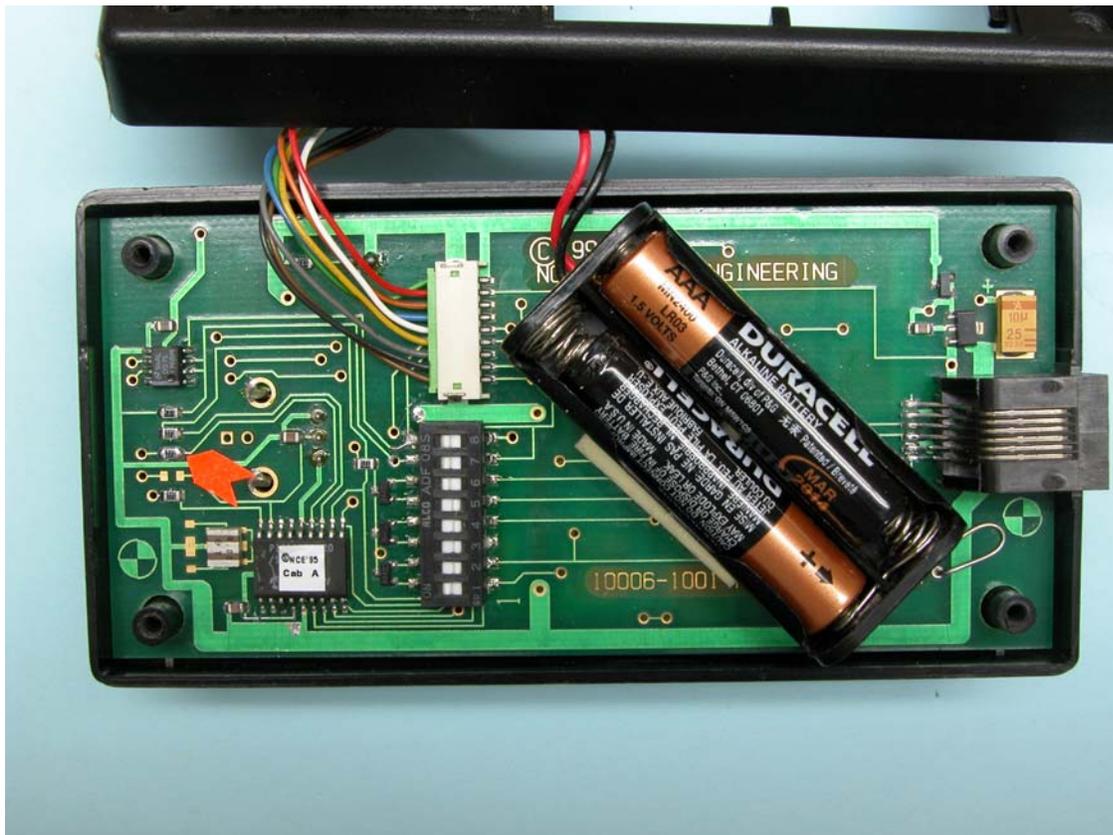
The problem is that the processor latches up when it sees the battery voltage applied to both of the horn contacts at startup. To fix this problem the 270 ohm resistor that is in series with the horn contacts can be increased to 1k ohms (1000 ohms). Increasing the value of the resistor prevents the latch up from occurring and the cab will always start normally regardless of how the horn button is pressed.

The general location of the resistor is shown at the orange arrow in the photo below:

Replace the resistor with a 1k ohm, 5%, 0805 package surface mount chip resistor. The resistor can be obtained in small quantities from Digikey or Mouser from any number of suppliers.

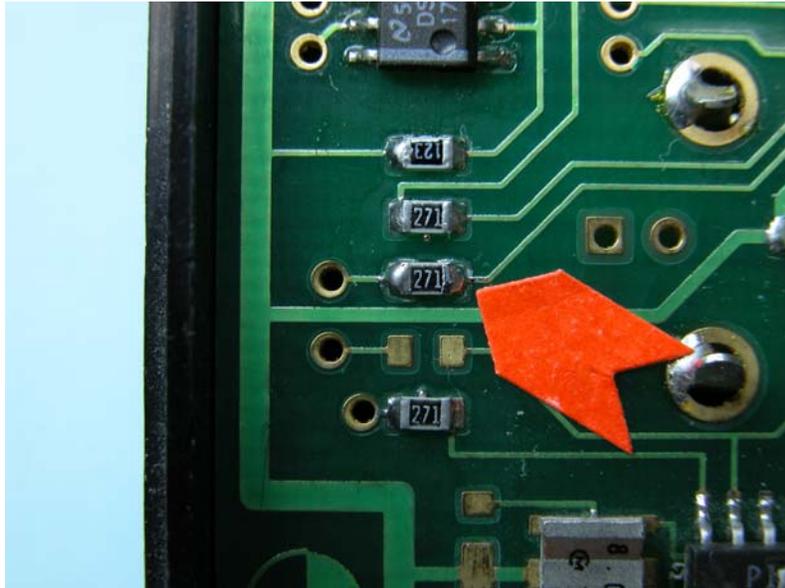
The photo below shows a close up of the 270 ohm (271 marking) resistor that needs to be changed:

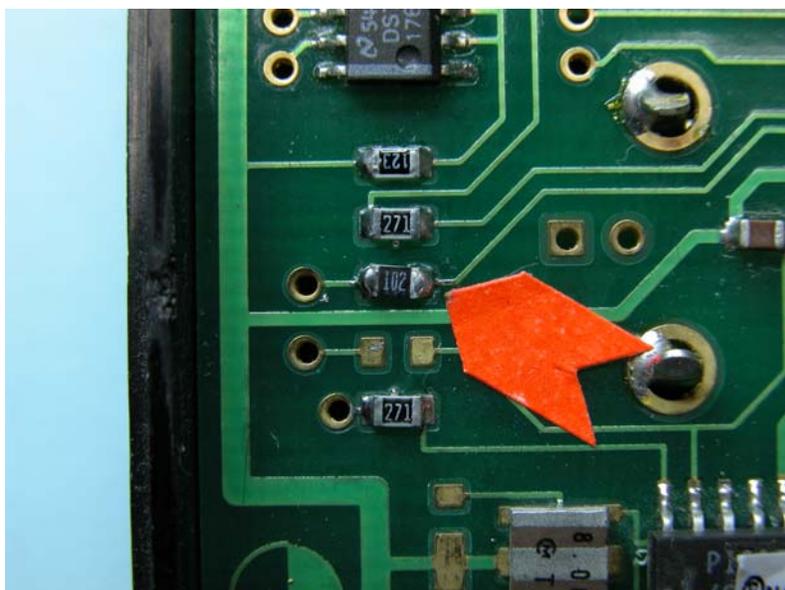
Here is another picture with the replacement 1k resistor (102 marking) installed.

The problem can be fixed by changing the value of the series resistor that is in line with the horn button. Changing this resistor from 270 ohms to 1k ohms will allow the cab to start up normally regardless of how the horn button is depressed.
